# FATIGUE BEHAVIOUR OF A ROLLED AZ31 MAGNESIUM ALLOYS PREPARED BY EP AND BB CONDITIONS

**Abstract:** Rotating bending fatigue tests have been performed using smooth specimens of a rolled AZ31 magnesium alloy in laboratory air at ambient temperature. Fatigue strength and characteristic was evaluated and fracture mechanism was discussed on the basis fracture surface analysis. Electrical polishing (EP) as well as deep rolling (ball burnishing (BB)) U-notched specimens were performed on two groups of samples, to evaluate optimum conditions for fatigue life. The microstructure and tensile properties of roll cast (RC) Mg- 3% Al- 1% Zn (AZ31) was investigated. The fatigue strength of 107 cycles around 100 MPa for deep rolling while it was around 40 MPa for Electrical polishing. It was very important to understand the effect of (ball burnishing (BB)) conditions on the hardness of the surface through to the core. The two procedures improved the fatigue performance, but better improve in results were found in ball burnishing. The growth of small cracks initiated at the surface coincided with the FCP characteristic after allowing for crack closure for large cracks, but the operative fracture

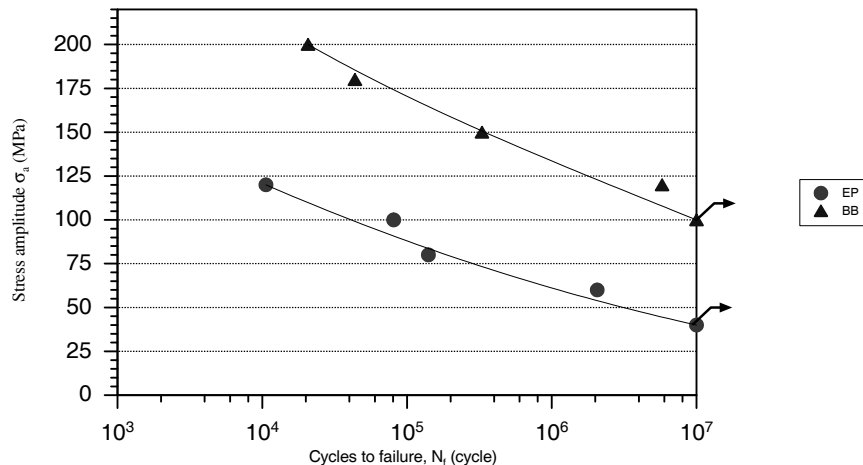
S/N curves for the EP and the BB specimens in laboratory at a stress ratio of -1 and frequency of 50 Hz (rolled magnesium alloy) in laboratory air is shown in Fig. 2. In this figure, for comparison purposes, the S–N curves of the EP and BB specimens are shown respectively. As seen from the figure, the fatigue life of the rolled magnesium alloy of EP specimen is relatively shorter than that of BB specimen. The extent bending in the S–N curve is gentler in the BB specimens than in the EP specimen. Next let us compare the S–N characteristics of the EP and BB specimens. There are great differences in the fatigue lives and in the fatigue limits, especially at higher stress amplitudes, there are differences in the fatigue lives.

**Fig.2.** S-N curve for rolled AZ31 at EP,BB conditions, rotating beam, R=-1, 50Hz.

4. Subsurface crack initiation occurred at applied stresses at 60 MPa. At BB condition but it can be seen for both 80 and 100 MPa stress for EP condition. The S-N diagram is shown in Fig. 2. It is well known that fatigue limit does not exist in non-ferrous alloys, thus fatigue tests were continued until  $10^7$  cycles. At EP condition  $\sigma = 40$  MPa, fatigue failure did not occur, but non-propagating cracks were observed on the specimen surface. As can be seen in the figure, the present Mg alloy seems to possess a definite fatigue limit, which may be related to the existence of non-propagating cracks. The fracture mode depending

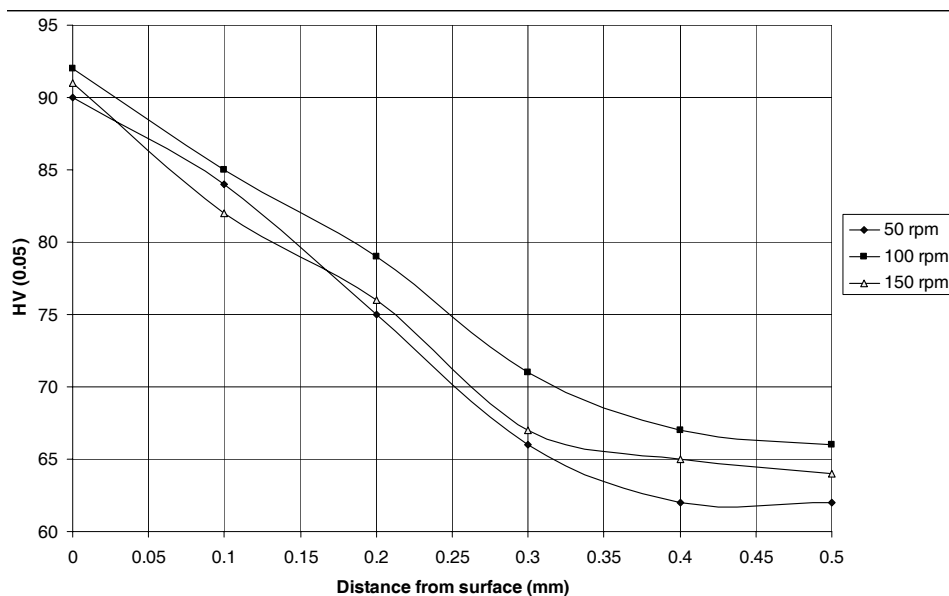
**3. 3.** A different experiment were used to investigate the best condition for BB (pressure, feed rate, speed) as example for tool HG3 200 bar (123 N) for 50, 100 and 150 rpm. The microhardness measurement from the surface in Fig. 3. Shows that the suitable condition for using 200 bars is 100 rpm for AZ31 as the hardness decreased from the circumference gradually to the center.

**Fig. 3.** Microhardness profile of AZ31 after BB at 200 bars, 0.17 mm/min at different BB rotation speed.
