IMPROVING PITTING CORROSION OF 304 STAINLESS STEEL BY ELECTROPOLISHING TECHNIQUE

M. Momeni, M. Esfandiari and M. H. Moayed*

Materials and Metallurgical Engineering Department, Faculty of Engineering, Ferdowsi University of Mashhad, Iran.

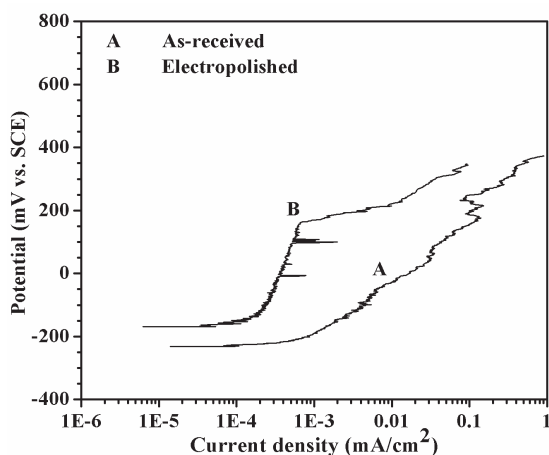
Fig. 1. Potentiodynamic polarization results for electropolished (red) and as-received (black) 316 StSt in 0.5M NaCl solution and 60mV/min scanning rate

Polarization results of two 304 SS samples in 0.5M NaCl are shown in figure 1. It is obvious that by electropolishing, passivity current density and corrosion current density were decreased and pitting potential as well as corrosion potential has shifted towards noble values. For instance, electropolishing increased 100mV in corrosion potential, 200mV in pitting potential and also passivity current density decreased for a decade. In view of the fact that pitting corrosion almost begins from deteriorated zones of passivity, such as surface inclusions and etc [10-17], superior pitting corrosion behavior of electropolished sample demonstrates a more integrated passivity with fewer defects in the passivity film in compare with

abraded as-received specimen. It elucidates that electropolishing process has a beneficial effect on pitting corrosion of 304 StSt. To evaluate the pitting corrosion behavior through metastable pit events, both of specimens were polarized from 100mV

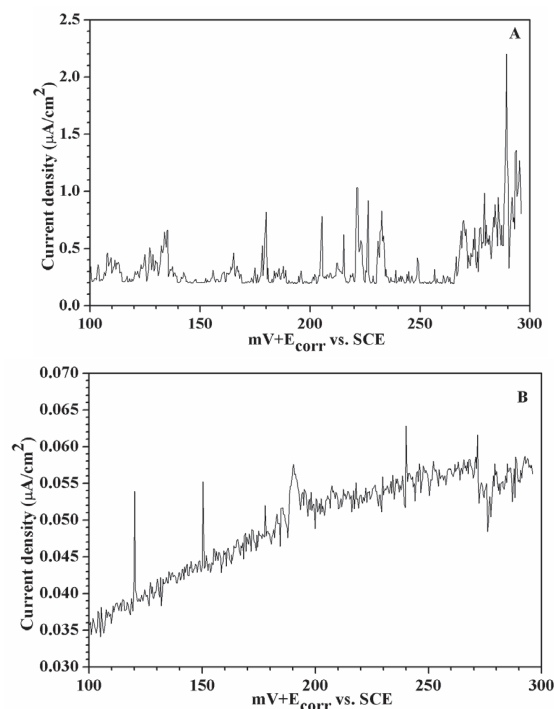
Fig. 2. Slow ramp anodic polarization of (A) as-received and (B) electropolished 316 StSt with 3mV/min scanning rate in potential range of 100-300 mV higher than E_{corr}

below corrosion potential towards anodic potentials and beyond pitting corrosion potential with a very slow sweeping rate (3mV/min). Figure 2 shows associated current density of polarization at the potential range of 100 to 300 mV above corrosion potential where the metastable pits were quiet obvious. It can be noticed that both as-received and electropolished samples were in passive state and no stable pit can be observed. However the magnitude of passive current density of electropolished specimen is much lower than abraded as-received one. Moreover decrease in the number and magnitude of metastable pits can be observed in electropolished sample. These results verify that pitting initiation sites have been considerably decreased in electropolished. This behavior was repeated in higher potentials, as an example the result of current density created in potential range of 300-500 mV above corrosion potential is shown in figure 3. It is evident that in this potential range electropolished sample still has lower passive current density than abraded

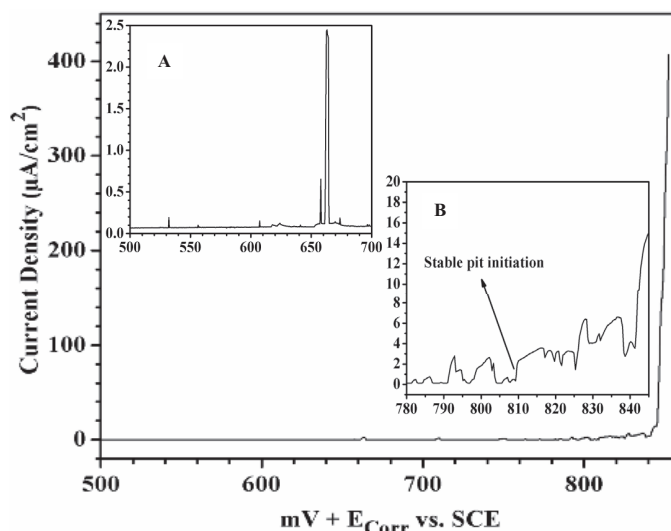
Fig. 4. Slow ramp anodic polarization of electropolished 316 StSt with 3mV/min scanning rate in potential range of 500-860 mV higher than E_{corr} (inserted micrograph A shows results in a range of 500-700 mV higher than E_{corr} and B shows potential which is stable pit initiated on surface)

as-received specimen. Besides as-received sample shows a sudden increase in its current density at 390 mV which is the indication of stable pits nucleation (inserted micrograph figure 3.a). However electropolished specimen is still in the passive state and only some metastable pits initiate in this potential range although the magnitude and number of these pits as well as passive current density are higher than previous potential range. By comparing these two potential ranges, it is apparent that current density in passive state for electropolished specimen has value of almost 100 times lower than as-received sample. To identify the pit initiation potential in electropolished specimen, the applied potential was continued to increase between 500 to 850mV above corrosion potential which is shown in figure 4. The working electrode is in passive state up to 810mV beyond corrosion potential and stable pits are nucleated at this potential. Current density was still in passive state in potential range of 500-700mV (inserted micrograph A) above corrosion potential. However the background value of passive current density and also magnitude of metastable pits was higher than two previous potential ranges. By judging against the result in noticed potential ranges for both specimens, it is comprehensible that electropolished specimen in potential range of 500-700mV has a comparable behavior of as-received

specimen in potential range of 100-300mV even though number and magnitude of metastable pits in as-received specimen in range of potential of 100-300mV is higher than electropolished specimen in 500-700mV. Moreover the results of slow sweeping potentials for these two specimens showed that electropolishing process increases pitting potential from 390 to 810 mV. It is revealed that electropolishing process in 70% phosphoric acid has considerable beneficial effect on pitting corrosion behavior of 304 SS. This method promotes pitting potential and also significantly decreases passive current density as it reported for mechanical polishing [18-21]. Moreover, the passive current density of electropolished specimen is much lower than as-received one. For instance, figure 5 shows result of potentiostatic at 400mV above rest potential on both working electrodes. The value of passive current density for electropolished sample is approximately 1000 times lower than as-received one. Additionally electropolished sample shows a current density in a range of passivity current density ($<10\mu\text{A}$) and despite the fact that as-received sample does not show pitting corrosion in this potential but its current density is not in a range of passivity current densities. Further anodic potentiostatic polarization even clarified the beneficial effect of electropolishing on electropolished specimen. For

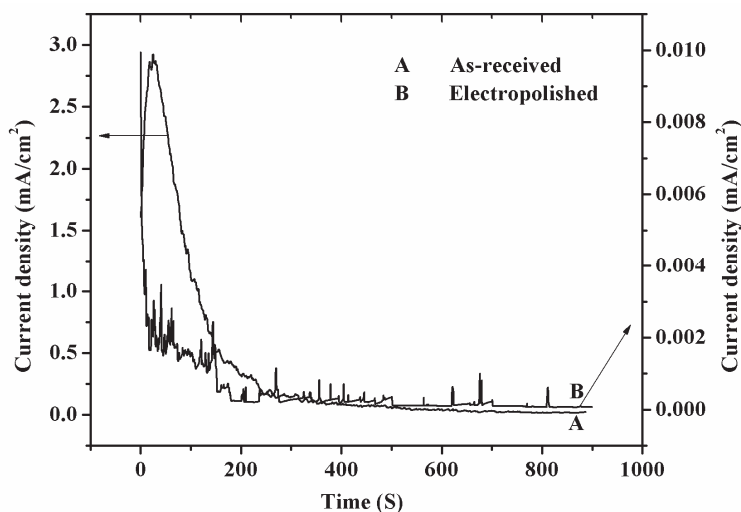
Fig. 5. Potentiostatic polarization results of (A) as-received and (B) Electropolished specimens in 400mV higher than corrosion potential

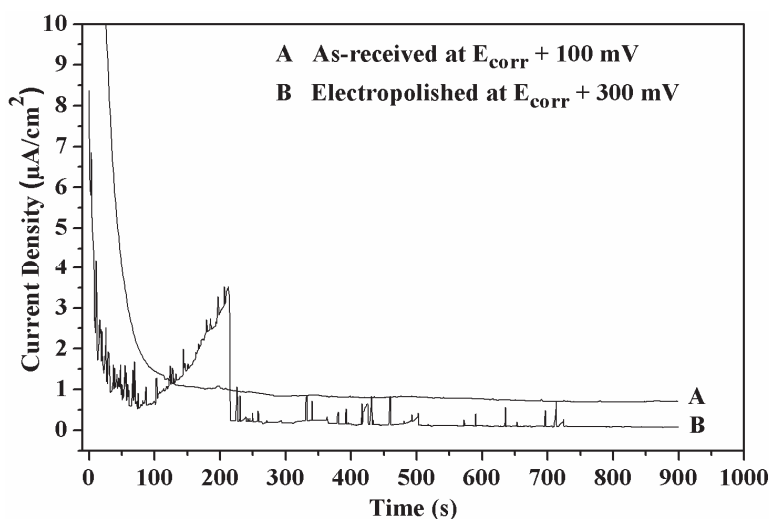
Fig. 6. Potentiostatic polarization results of (A) as-received in 100mV higher than E_{corr} and (B) Electropolished specimens in 300mV higher than E_{corr}

example figure 6 shows results of potentiostatic test in which as-received specimen was polarized in 100mV and electropolished sample in 300mV above corrosion potential. Even though electropolished specimen has been polarized 200mV more than as-received specimen but still shows remarkably lower passive current density. The reason of featuring metastable pitting current transients which can be observed as fluctuation of current density on electropolished specimens is attributed to the lower passivity current density background. When the passive current density background is very small, the

small metastable pit events can also be observed which shifting the passive current density background to a higher values; as for as-received specimen, the small events are not able to rise beyond the background and so they can not be observed.

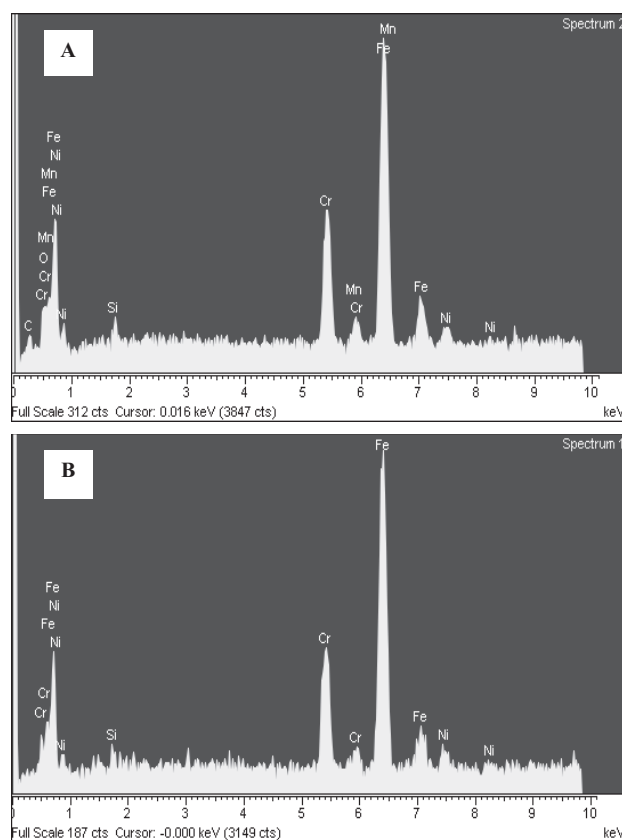
Fig. 7. EDX analysis results for (A) as-received specimen and (B) electropolished

The superior pitting corrosion properties of electropolished sample can be explain by either modification in surface roughness or chemical composition changes mainly due to chromium enrichment on the surface [14-18]. EDX analysis of specimen surface is shown in figure 7. In electropolished specimen the presence of manganese is not observed and in contrast with as-received specimen its distinguishable peak was eliminated. Besides the intensity of peaks related to Fe, Cr and Ni elements have not significantly changed. Consequently the

enhanced pitting properties of electropolished sample can be explained by modification in surface roughness and removal of MnS inclusions rather than significant chemical composition changes of the surface. In fact as it was explicated above, electropolishing may change the surface chemical composition and by enrichment of chromium, the surface creates a better passivity property with lower defects [10-14]. However in this case, although the absence of manganese in electropolished surface may confirm a surface with different chemical composition in compare with as-received one, but it suggests that the most essential reason of improving in pitting properties was modification in surface roughness and possible removal of MnS inclusions. As it reported elsewhere [22], electropolishing and acid pickling are two methods that causes manganese sulfide removal. Conclusively, electropolishing process reduces

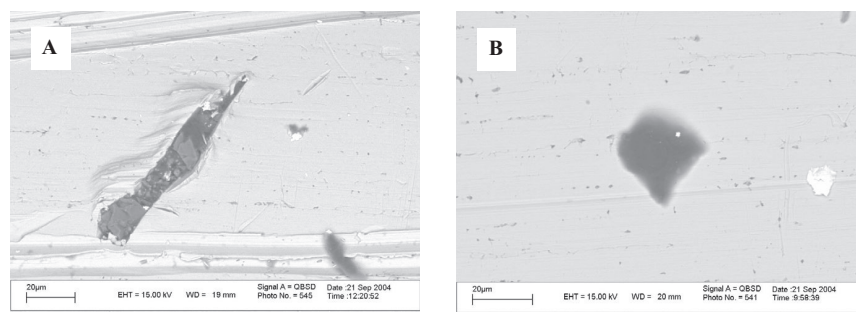
Fig. 8. SEM micrograph analysis of pit initiated on surface for (A) as-received and (B) electropolished specimen

To evaluate the morphology of pits initiated beyond pitting potential, both surfaces were analysis with scanning electron microscope (SEM). Figure 8 shows the SEM result of pits morphology on both sample surface. Figure 8.a shows that on as-received sample, pit was initiated from surface scratch which was created in polishing process by 60 SiC grit. In fact these surface scratches act as a nucleation site for pits [14-18]. During surface electropolishing, removal of surface roughness, decrease the pit nucleation sites. Figure 8.b shows the picture of stable pit which is nucleated on vicinity of remaining groove of surface scratch which may be preserved from scratches that already created from abrading with SiC paper prior to electropolishing.

These results reveals that as it elucidated in previous section, electropolishing improved passivity by modification in surface structure and removing surface scratches which were produced in surface finishing of 60 SiC grit step. Moreover another reason behind this enhancement of pitting corrosion potential of electropolished specimen can be attributed to producing a surface with lower residual stress in compare with surface polished of 60 SiC grit. In fact as it clarify
