# Influence of Friction Stir Processing Parameters on the Mechanical and Corrosion Properties of Al-Cu-Li Alloy

**Abstract:** In this work, AA2050 alloy was friction stir processed at various tool rotation speeds and feed rates. The material was subjected to artificial aging to investigate its influence on macrostructure, microstructure, microhardness, and tensile strength of friction stir processed AA2050. In addition, a hot salt corrosion test was done on the test specimens at 130°C for 168 hours. The results indicated that grain refinement and dispersion of secondary phase particles improved the microhardness and strength of friction stir processed specimens. The artificial aging of the friction stir processed specimens improved the ductility by 81.5%. However, the tensile strength of the specimens decreased by 2.8%. The corrosion (mass loss per unit area) of the specimen processed with a single pass at a speed of 600 rpm and feed rate of 60 mm/min decreased by 90% compared to the base material.

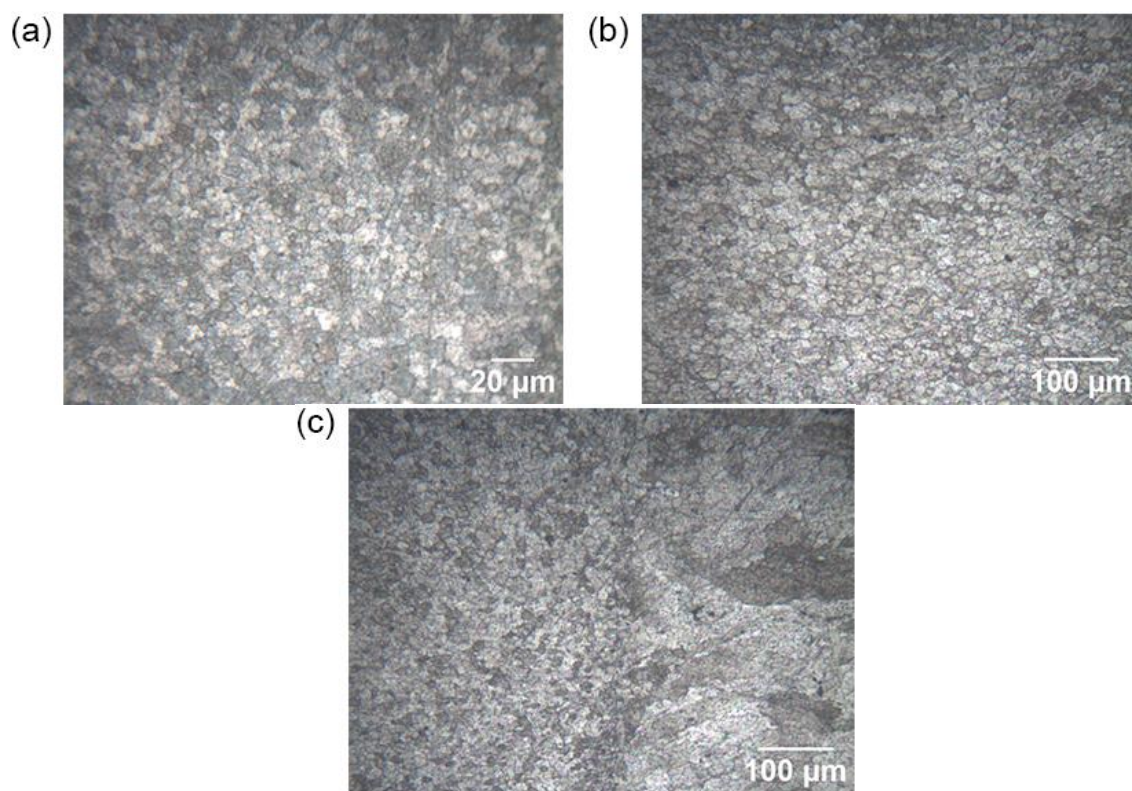
**Fig. 4.** Microstructure of specimen (a) J at 500× magnification; (b) K at 200× magnification (c) L at 200× magnification

During FSP, the frictional heating of the FSP tool (tool shoulder and tool pin against the workpiece) plasticized material. The traverse of the FSP tool transferred the plasticized material from the front to the rear position of the tool pin, breaking the grain boundaries. The material flowing around the pin of the tool filled the space behind the tool. Also, the recovery and recrystallization phenomenon resulted in smaller and more refined grains. The typical microstructure indicating the grain refinement and dispersion of intermetallic phases is depicted in Figure 4. The typical microstructure of specimen J, specimen K, and specimen L is shown in Figure 4 (a), Figure 4 (b), and Figure 4 (c), respectively.

The average grain size of specimen G was 25.6  $\mu\text{m}$ , specimen H was 27.2  $\mu\text{m}$ , specimen I was 18.47  $\mu\text{m}$ , specimen J was 17.96  $\mu\text{m}$ , specimen K was 24.45  $\mu\text{m}$ , and specimen L was 23.17  $\mu\text{m}$ . The base material had larger grains, as observed in Figure 4 (c). Conventionally, heat treatment refines the grain size and increases the precipitation of the intermetallic phases in AA2050 alloy [24, 25]. The average grain size of specimen G was 26.23  $\mu\text{m}$ , specimen H was 15.51  $\mu\text{m}$ , specimen I was 21.49  $\mu\text{m}$ , specimen J was 29.36  $\mu\text{m}$ , specimen K was 24.45  $\mu\text{m}$ , and specimen L was 12.96  $\mu\text{m}$ . It is observed that heat treatment has coarsened grains in most of the FSPed specimens. The typical microstructure of specimen K and specimen I are shown in Figures 5 (a) and Figure 5 (b), respectively.

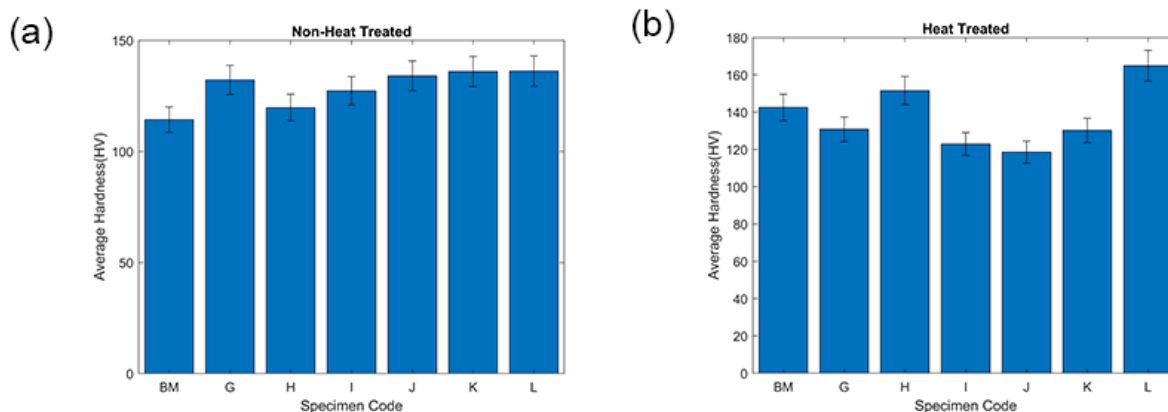
Fig. 7. Microhardness (a) non-heat-treated specimens; (b) heat-treated specimens

The microhardness is inversely proportional to the grain size of the material. However, not much variation was noticed between the microhardness of FSPed specimens (specimen G through specimen L). All the non-heat-treated FSPed specimens had an average microhardness of 130.86 HV which is greater than that of the non-heat-treated base material (114.28 HV). This is because of the refined microstructure. However, after heat treatment, grains coarsened in the specimens. The coarsening of grains resulted in low microhardness of specimen G (130.8 HV), the specimen I (122.93 HV), specimen J (118.56 HV), and specimen K (130.2 HV). After heat treatment, these specimens had lesser microhardness than the base material (142.48 HV). The Vickers microhardness of the base material (BM) and FSPed specimens before and after heat treatment are shown in Figure 7. Specimen G through specimen L had more hardness in the nugget zone than in other zones.

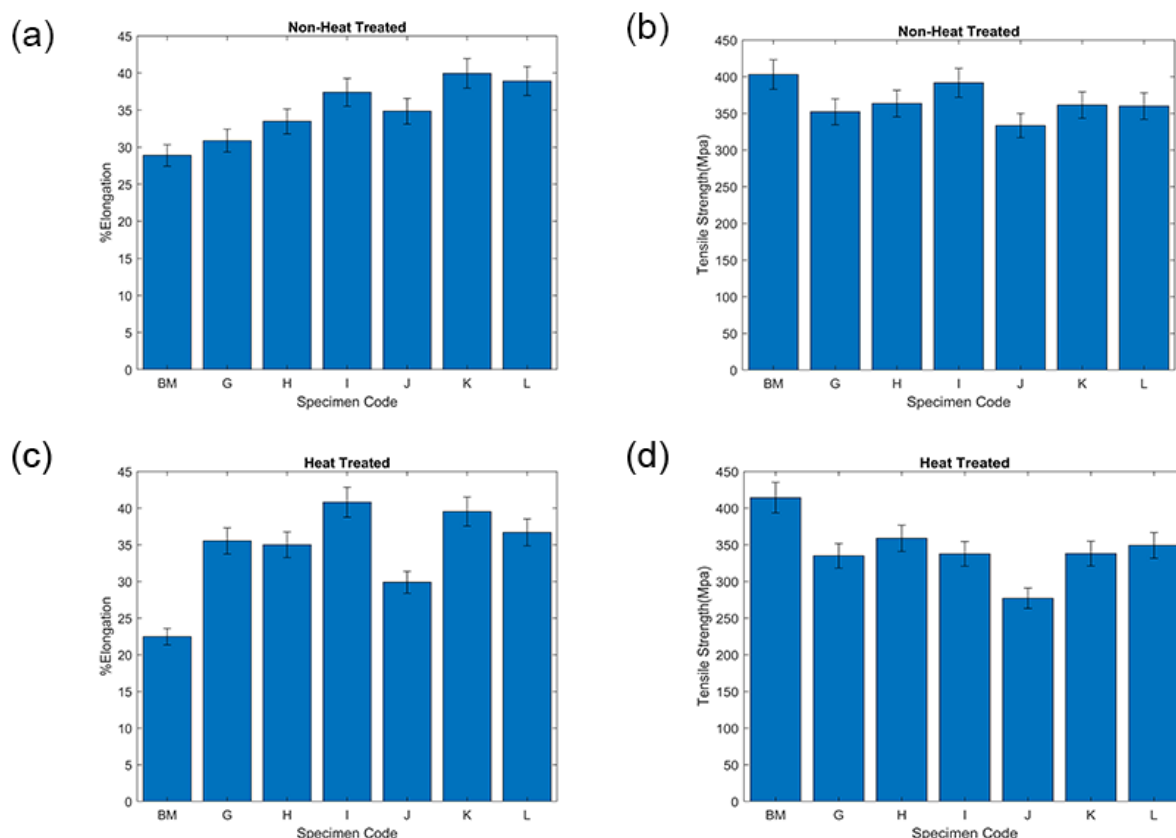
**Fig. 8.** (a) Non-heat-treated specimens percentage elongation; (b) Non-heat-treated specimens tensile strength; (c) Heat-treated specimens percentage elongation; (d) heat-treated specimens tensile strength

The tensile strength and ductility of the base material and FSPed specimens in heat-treated and non-heat-treated conditions are shown in Figure

8. The tensile strength of the FSPed specimens was lower than the base material. However, the ductility of the material improved after friction stir processing. The base material, specimen G, specimen H, specimen I, specimen J, specimen K, and specimen L had a tensile strength of 402.92 MPa, 352.08 MPa, 363.33 MPa, 391.67 MPa, 333.33 MPa, 361.25 MPa, and 360 MPa respectively. Approximately ~10% reduction was observed in the tensile strength of the FSPed specimens than the base material.

The base material, specimen G, specimen H, specimen I, specimen J, specimen K, and specimen L had an elongation of 28.89%, 30.88%, 33.48%, 37.4%, 34.84%, 39.95%, and 38.92%, respectively. The percentage elongation of most of the non-heat-treated FSPed specimens was higher than the base material. After the tensile test, the fractured region of the base material was observed under the high-resolution scanning electron microscope. The fractography of the base material is shown in Figure 9.
