# FATIGUE BEHAVIOUR OF A ROLLED AZ31 MAGNESIUM ALLOYS PREPARED BY EP AND BB CONDITIONS

**Abstract:** Rotating bending fatigue tests have been performed using smooth specimens of a rolled AZ31 magnesium alloy in laboratory air at ambient temperature. Fatigue strength and characteristic was evaluated and fracture mechanism was discussed on the basis fracture surface analysis. Electrical polishing (EP) as well as deep rolling (ball burnishing (BB)) U-notched specimens were performed on two groups of samples, to evaluate optimum conditions for fatigue life. The microstructure and tensile properties of roll cast (RC) Mg- 3% Al- 1% Zn (AZ31) was investigated. The fatigue strength of 107 cycles around 100 MPa for deep rolling while it was around 40 MPa for Electrical polishing. It was very important to understand the effect of (ball burnishing (BB)) conditions on the hardness of the surface through to the core. The two procedures improved the fatigue performance, but better improve in results were found in ball burnishing. The growth of small cracks initiated at the surface coincided with the FCP characteristic after allowing for crack closure for large cracks, but the operative fracture

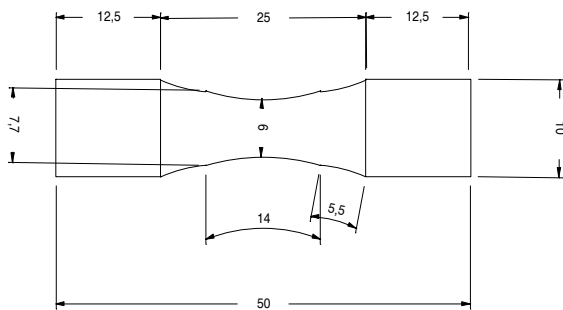
**Fig. 1.** Shape and dimension of mechanical testing specimens

As shown in Fig. 1. Mechanical testing tensile and fatigue specimens with 5 mm diameter, 14 mm gauge length was machined from as-received so that their axis is parallel to the rolling direction. BB condition prepared with the following preparation condition on ECOROLL instrument using tool type (HG6) at 100 bar (246 N) with feed rate of 0.17 mm/min at 30 rpm.

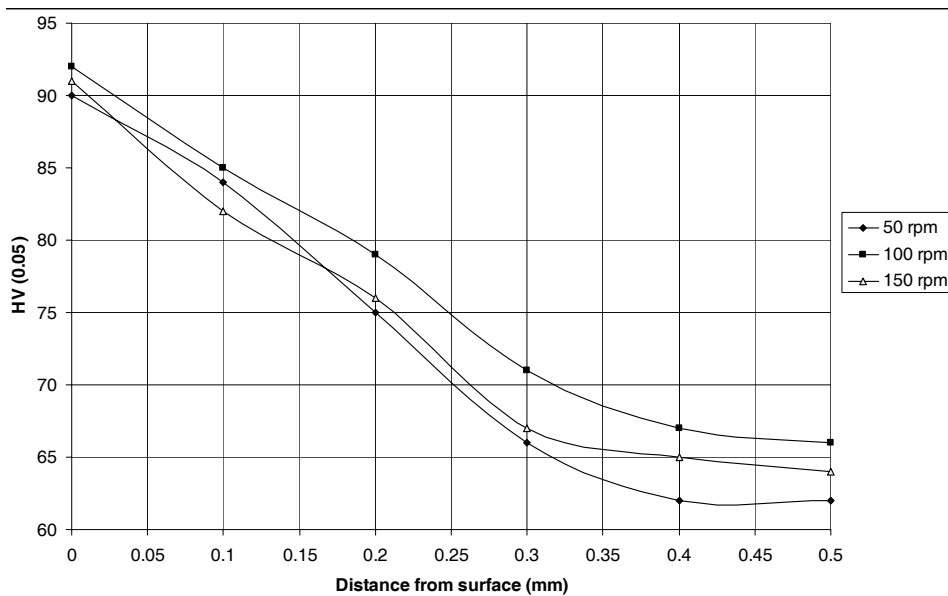
Fig. 3. Microhardness profile of AZ31 after BB at 200 bars, 0.17 mm/min at different BB rotation speed.

3. 3. A different experiment were used to investigate the best condition for BB (pressure, feed rate, speed) as example for tool HG3 200 bar (123 N) for 50, 100 and 150 rpm. The microhardness measurement from the surface in Fig. 3. Shows that the suitable condition for using 200 bars is 100 rpm for AZ31 as the hardness decreased from the circumference gradually to the center.
